Bungalows to Mansions

Inspection Report

1904 5th Ave

Gainesville FL 32601

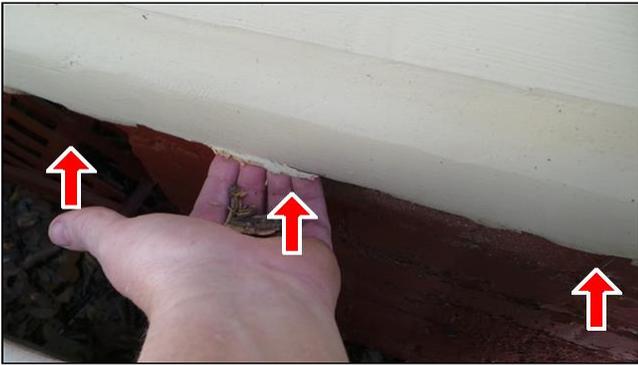
1.0 Picture 1

1.0 Photos show signs of minor moisture damage around the home, mostly on the 5th street side. Photos 9-11 show no kick out flashings. Recommend repairs as needed and adding kickout flashings (photo 12) where needed to help prevent future damage.

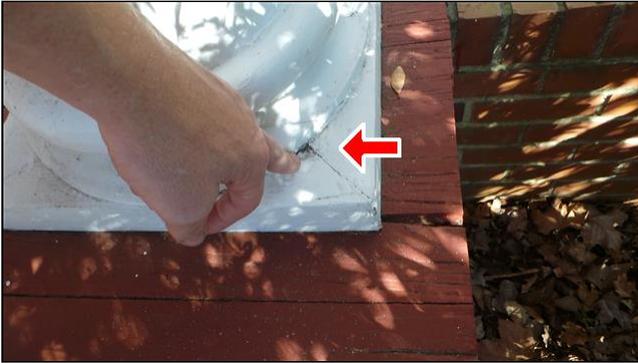
1.1 Picture 1

1.1 Photos show signs of moisture damage around the home. Recommend repairs as needed. Photos 7-10 show that some of the windows only have partial top flashings. Recommend installing full size flashings (photo 10) on the top window trim to help prevent future moisture damage.

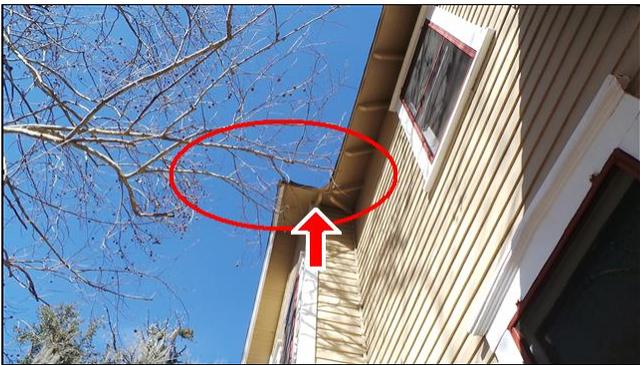
2.2 Picture 1

2.2 Recommend trimming all trees in contact with the building.

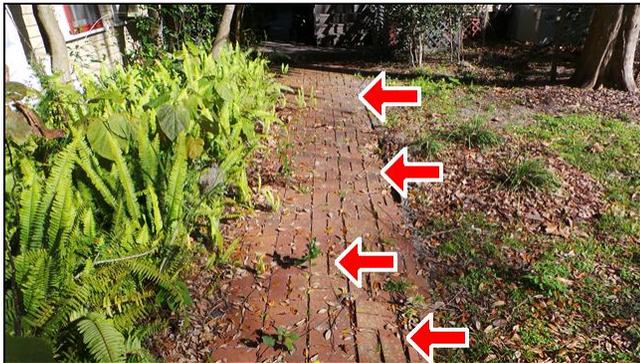
3.0 Picture 1

3.0 Some uneven areas observed in the brick walkway and sidewalk and some moisture damage to the wooden walkway. Consider leveling of uneven areas to prevent trip hazards.

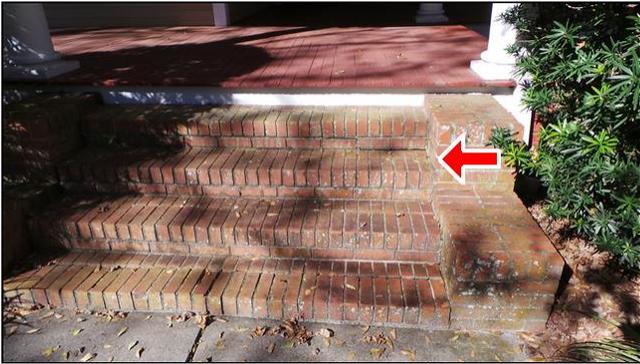
4.0 Picture 1

4.0 Photo 1 shows a minor settlement crack on the front steps. Photo 2 shows a set of steps in the rear with 4 or more steps and no railing. Recommend adding railing. Photo 3 shows failing paint on rear steps. Photo 4 shows a moisture damaged railing for the rear deck. Recommend replacement. Photos 5-7 shows that the steps to the outbuilding have rotated forward due to moisture damage, also note that there is no landing with the out swing door. Recommend repairs as needed.

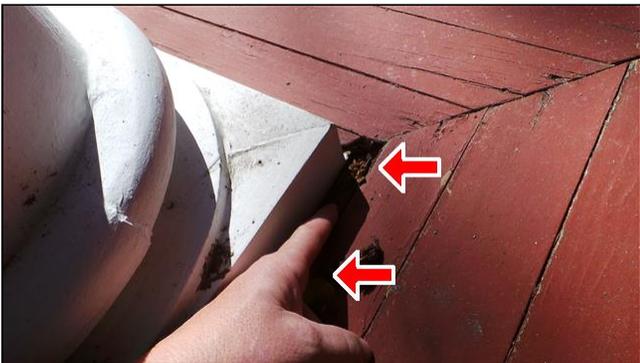
4.2 Picture 1

4.2 Photos show minor moisture damage to include compression damage at a couple of the front post. Recommend repairs as needed.

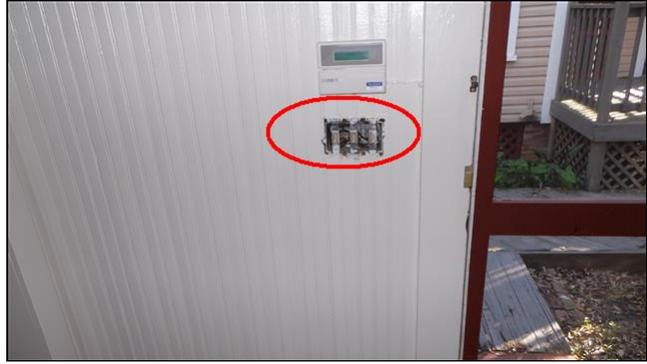
4.6 Picture 6 missing cover plate

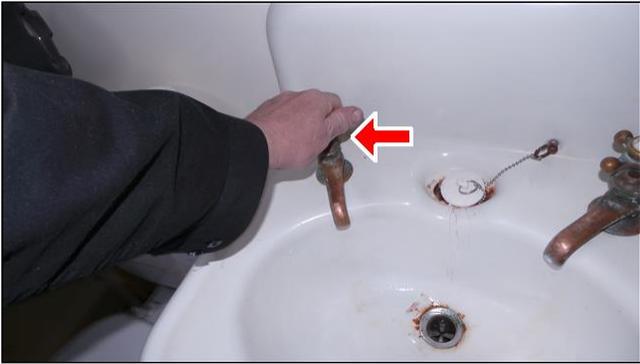
4.6 Picture 7 hot water valve not working

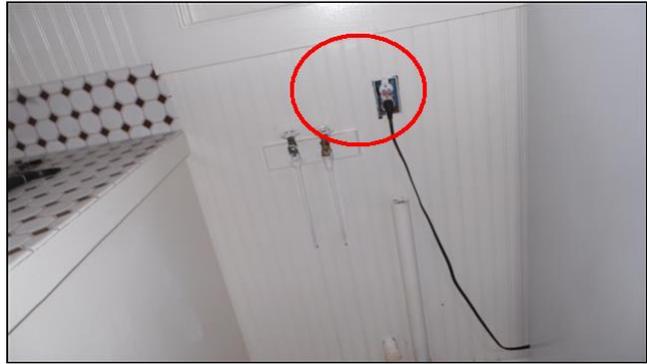
4.6 Picture 8 missing cover plate

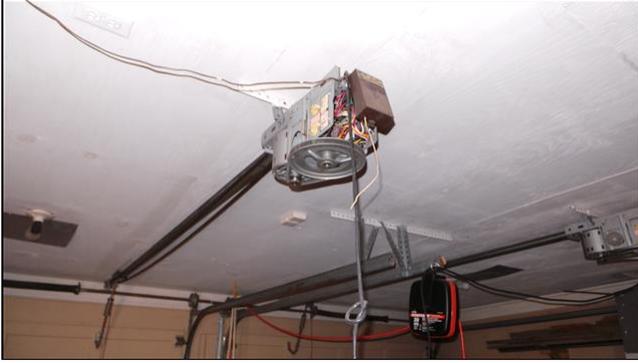
6.5 Picture 1

6.5 The left side opener was not operating properly. Both units are aged and missing covers. Recommend repairs or replacement as needed.

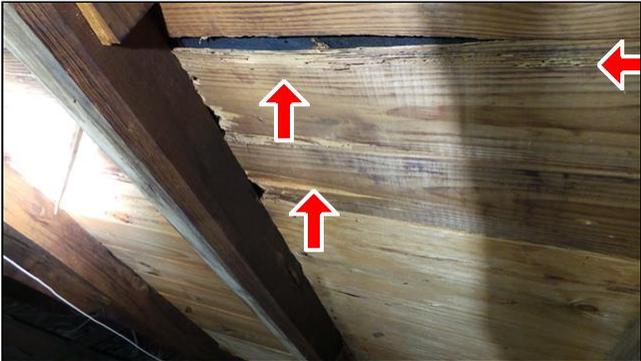
7.1 Picture 1

7.1 Photos show signs of past WDO damage. Recommend a complete WDO inspection.

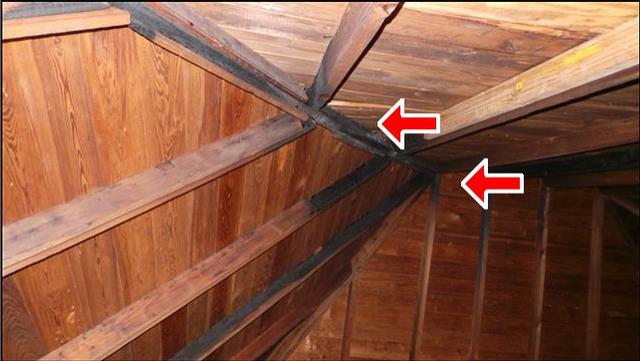
7.2 Picture 1

7.2 Photos show signs of past fire damage and misc. repairs. Recommend review by a structural engineer for your safety.

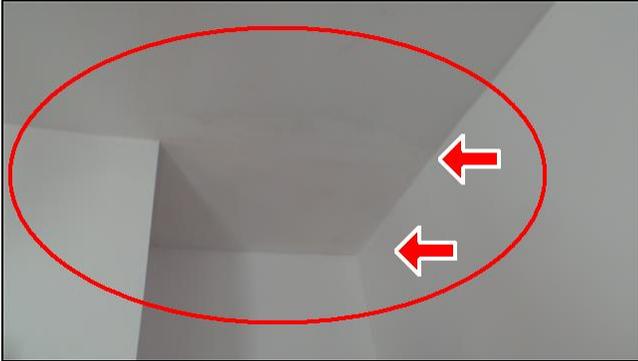
8.0 Picture 1

8.0 Photos 1-2 show signs of past moisture event, both areas tested dry at the time of the inspection. Photos 3-4 show flaking paint on the upstairs balcony. Recommend corrective action as needed due to the possibility of lead paint in the home.

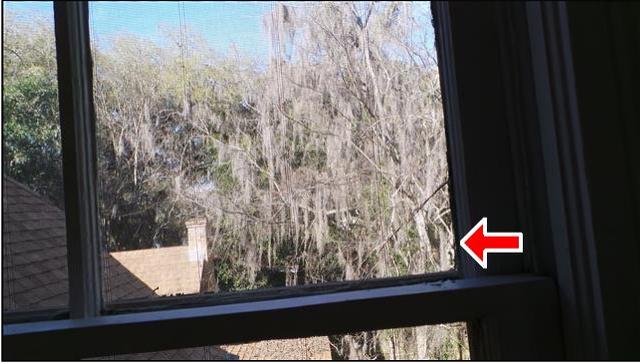
8.1 Picture 1

8.1 Several windows are cracked. Recommend repairs as needed.

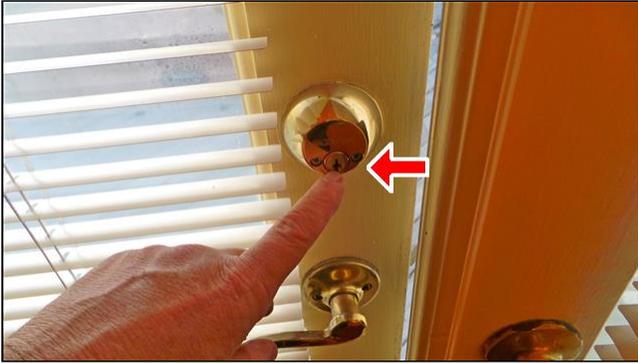
8.2 Picture 1

8.2 Recommend that all interior egress doors have thumb latches for your safety. Photo 2 shows a loose security sensor. Photo 3 shows that the rear door from the kitchen is sticking at the top. Recommend adjustments as needed.

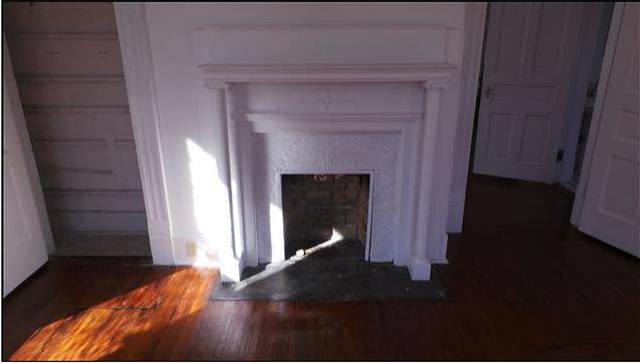
9.1 Picture 1

9.1 The fireplaces are in disrepair and are unsafe. Recommend a [level II inspection](#) and any repairs as needed on all chimneys and fireplaces prior to starting any fires.

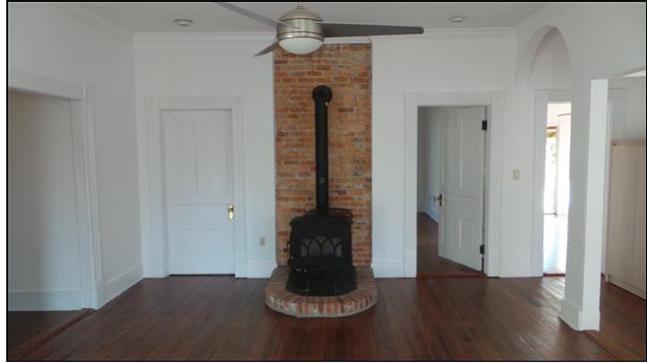
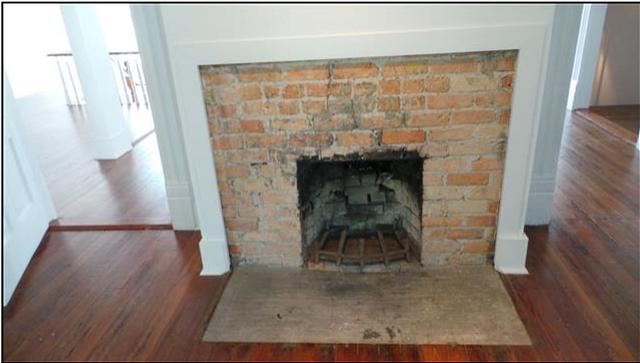
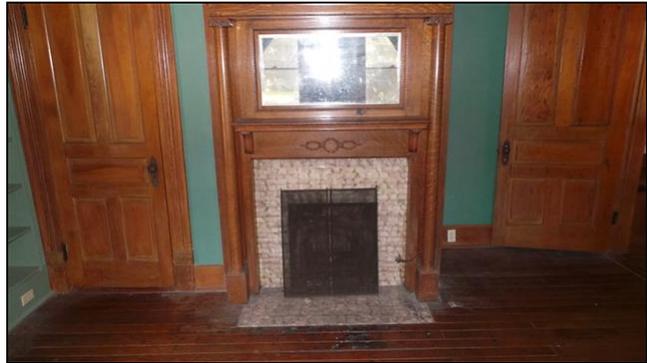
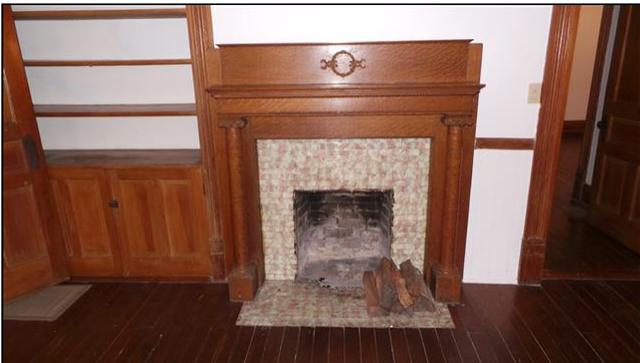
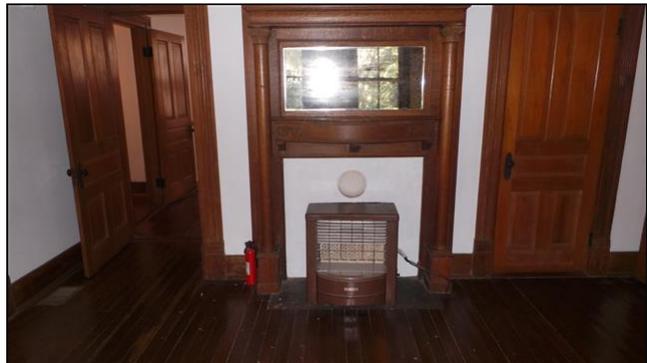
9.4 The fireplaces are in disrepair and are unsafe. Recommend a [level II inspection](#) and any repairs as needed on all chimneys and fireplaces prior to starting any fires.

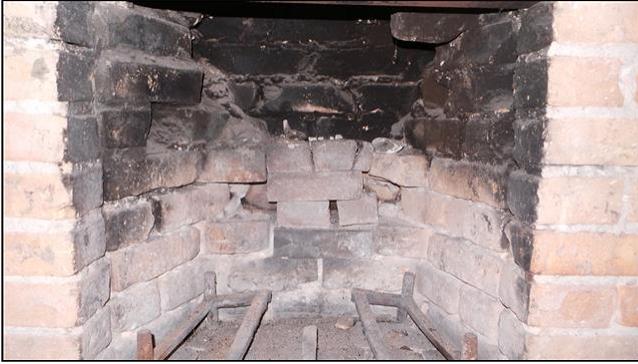
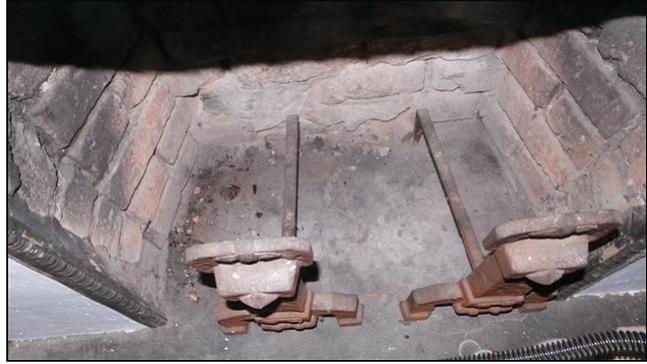
9.2 Complimentary View.

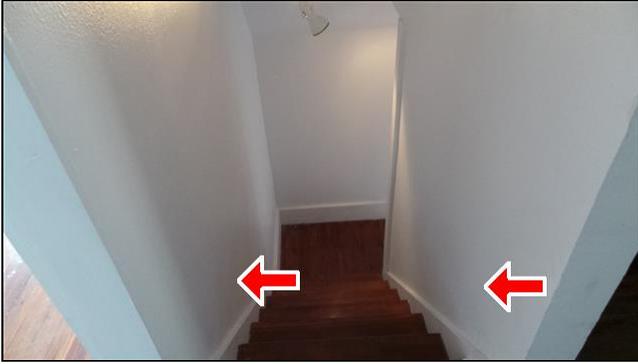
9.5 Picture 1

9.5 Recommend adding a hand rail to the rear steps for your safety.

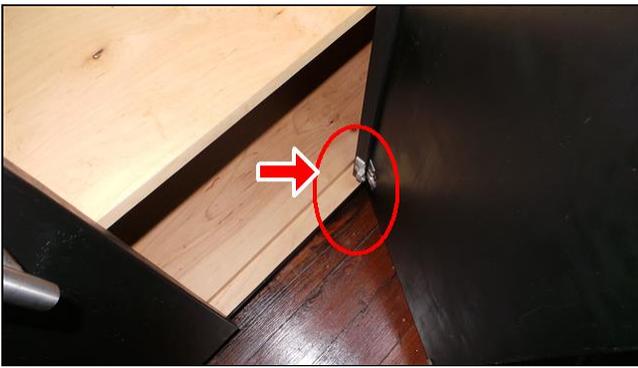
9.7 Picture 1

9.7 Photo shows a loose hinge in the upstairs bar area. Recommend repairs as needed.

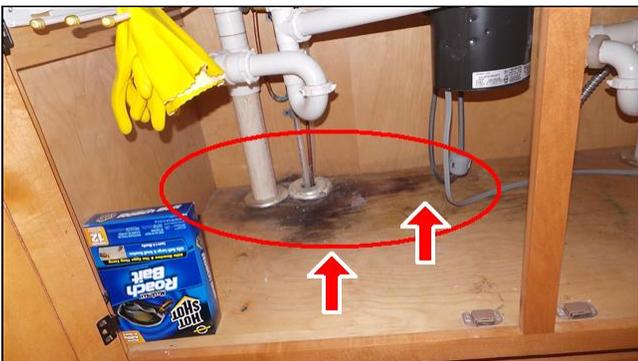
10.6 Picture 1

10.6 Photo shows signs of past moisture damage, this area was dry at the time of the inspection. Recommend sealing and painting.

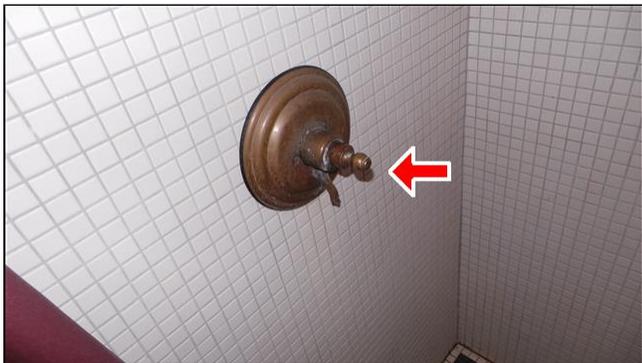
11.1 Picture 1

11.1 Photo shows missing valve handle. Recommend repairs as needed.

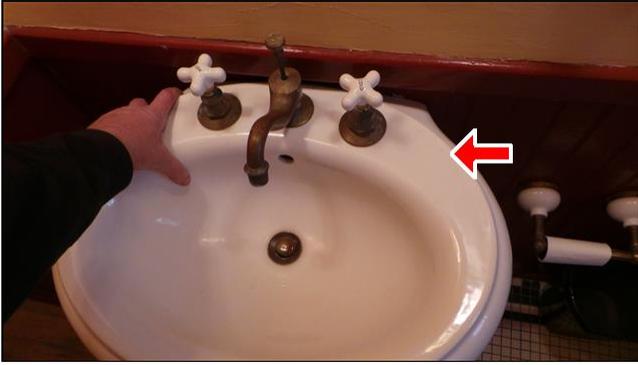
11.6 Picture 1

11.6 Photo shows that the sink is loose on the wall in the downstairs bathroom. Recommend repairs as needed.

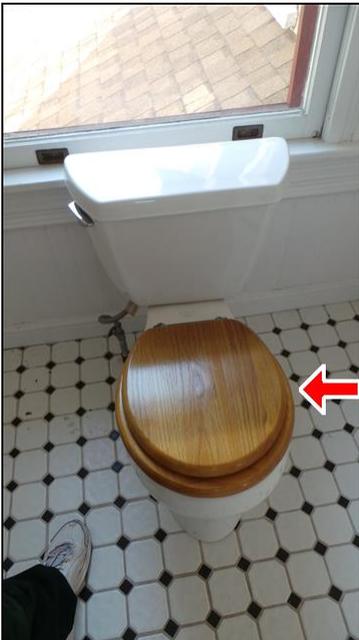
11.10 Picture 1

11.10 Photo 1 shows a loose toilet in the front upstairs bathroom. Photo 2 shows a nonworking toilet in the guest house. Recommend tightening and or replacement of the wax ring as needed.

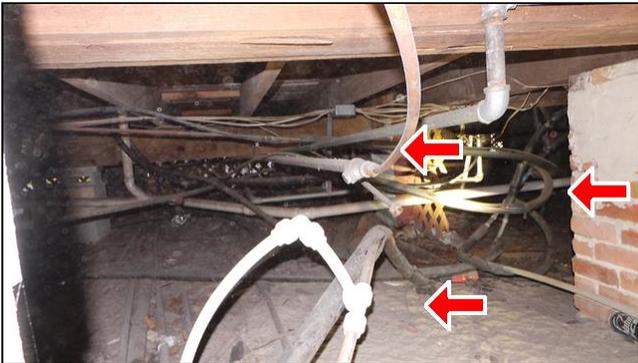
12.1 Picture 1

12.1 Photos show a haphazard mix of water lines that are unsupported, lying on the ground, and are un-insulated. Recommend repairs as needed.

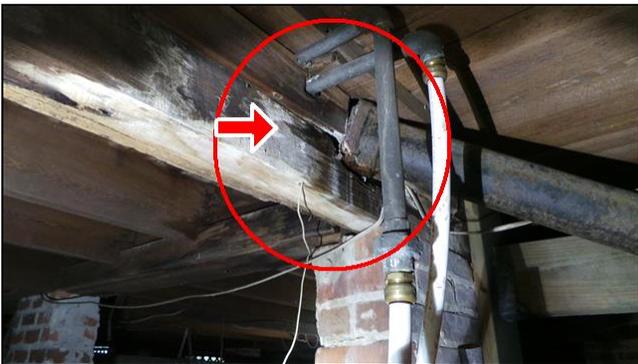
12.3 Picture 1

12.3 Photos show active leak in the crawl space, it is unknown if this is a drain or supply line leak. Recommend repairs as needed.

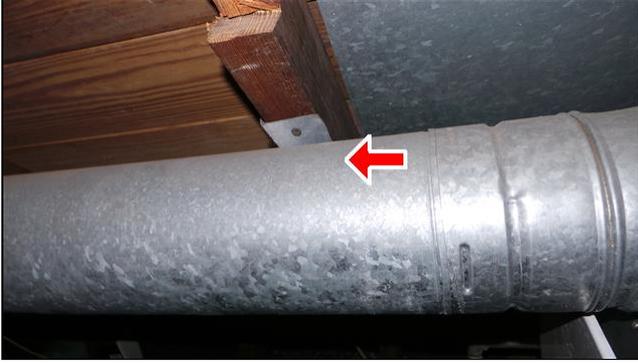
12.4 Picture 1

12.4 The flue for the upstairs water heater is run too close to combustibile materials. Recommend repairs as needed.

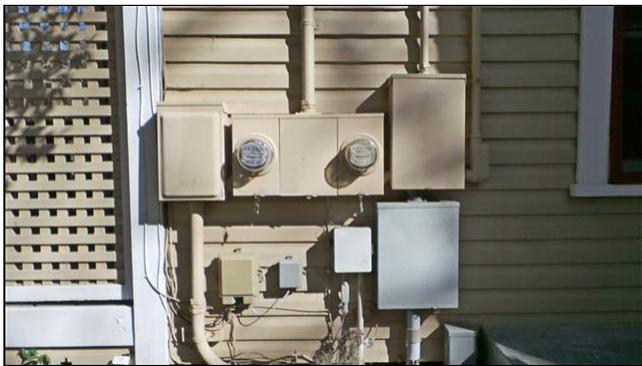
13.0 Picture 1

13.0 Main panel boxes are located on the outside of the home.

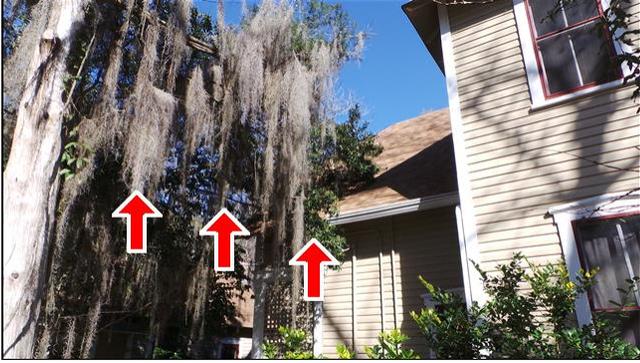
13.2 Picture 1

13.2 Service entrance cable is running thru the trees. Recommend trimming any branches that are in contact.

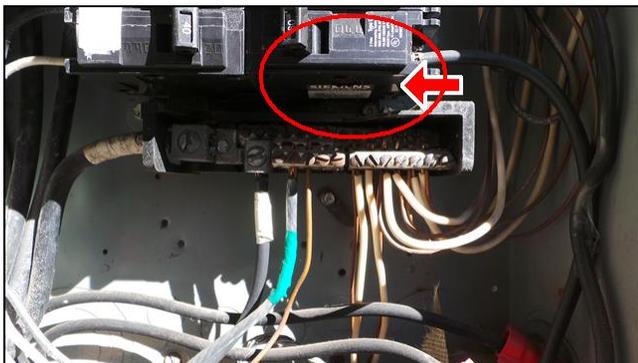
13.5 Picture 3

13.5 Photos 1-2 There are multiple neutrals and neutrals and grounds terminated together, all neutrals should terminate individually. Photo 3 shows mixed manufacture breakers installed. Photo 5 shows grounds and neutrals not properly separated in the interior distribution panel. Recommend repairs as needed by a certified electrical contractor.

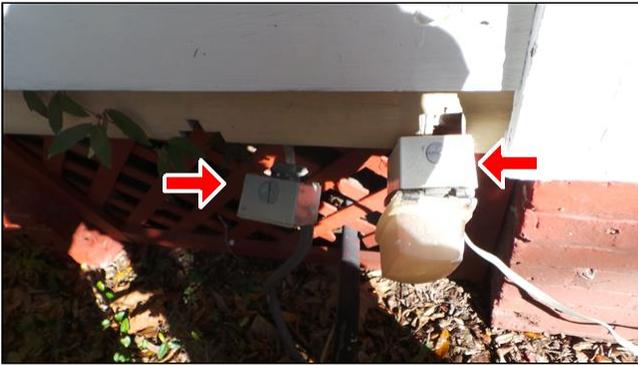
13.6 Picture 1

13.6 Photo 1 shows loose junction boxes. Photos 2-4 shows ungrounded outlets that have been upgraded to 3 prong receptacles. Photos 5-9 show open junction boxes in the attic and crawl space. Recommend repairs as needed by a certified electrical contractor.

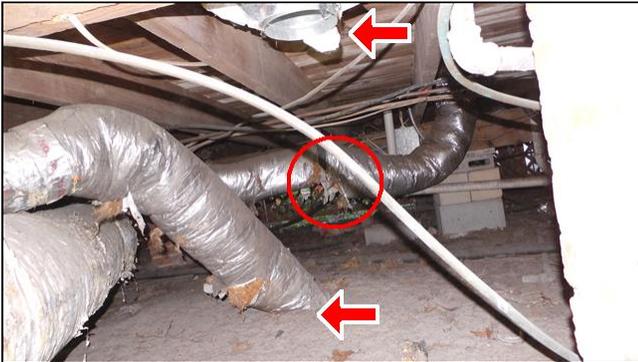
14.4 Picture 1

14.4 Photo shows loose insulation and a disconnected duct run in the crawl space. Recommend repairs as needed.

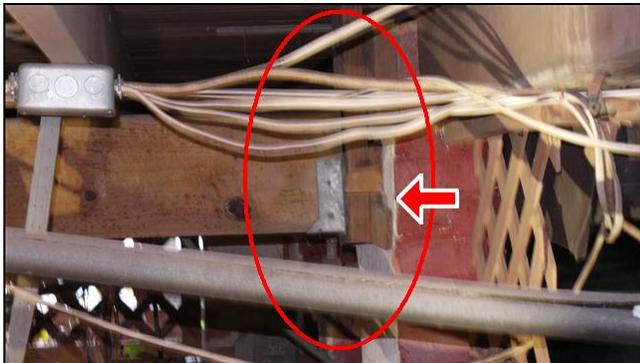
15.1 Picture 1

15.1 There are multiple beams in the crawl space that are not properly supported on their ends. Recommend repairs as needed.
